Service Info

Assembly instructions for tensioning pulley 531 0203 20

Part no.: 531 0203 20
 530 0171 10
 530 0171 30

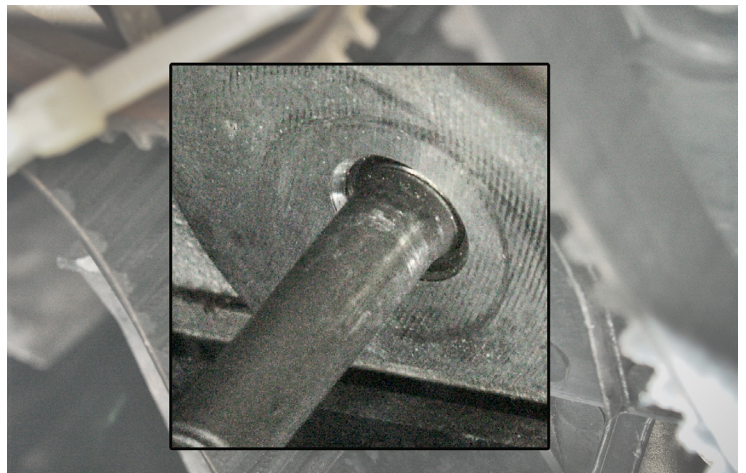
Image 2: The stud is correctly screwed in

When installing tensioning pulley 531 0203 20, you must ensure that the thread (M10) on the stud is fully screwed into and flush with the engine block. The thread must not protrude from the block (see Image 2).

You must ensure that the thread on the stud lies flush or below the engine block! If the stud is in any other position, this may cause the tensioning pulley to malfunction!

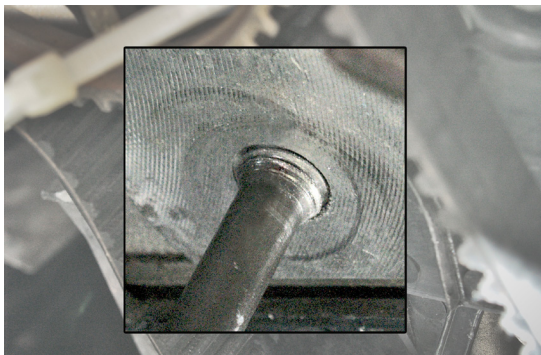
Image 1: The stud is not correctly screwed in

If the thread (M10) on the stud is not completely screwed in (see Image 1), the tensioning pulley does not lie flush with the surface of the engine block and will therefore become damaged. Tightening the tensioner onto the protruding threaded portion of the stud will give the impression that the tensioner is correctly clamped.

When the engine is running, the resulting forces in the tensioning pulley may cause the stud/tensioner to come loose, which could lead to major engine damage.
