## Service Info

# Clutch grabs when shunting

Manufacturer: Mercedes-Benz

Models: Actros MP 2 (2003 - 2008)  
Actros MP 3 (2008 - )

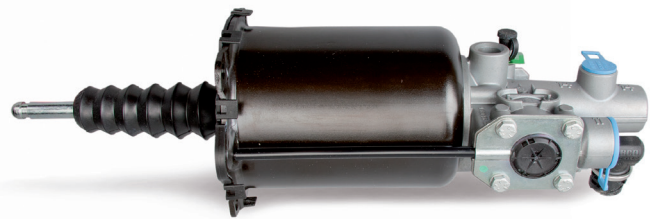
Image 1: The part number of the clutch booster must be checked

In the models listed above, the clutch may grab during shunting. The malfunction can be caused by inaccurate clutch regulation or an obsolete clutch booster. The following procedure is recommended for a professional repair:

- Replace the clutch booster with part no.: 000 250 0062 with part no.: 000 250 0562. Replace Wabco part no.: 9701500020 with part no.: 9701500010
- Check the setting of the clutch booster ram (see SI 0054) and adjust if necessary

- Put the transmission control in ,learn mode' in accordance with the specifications provided by the vehicle manufacturer
- If a dual disc clutch has been installed, the setting of parameter 1 in the transmission control and the clutch wear in parameter 3 must be corrected according to the specifications provided by the vehicle manufacturer

If the malfunction persists after all measures have been implemented, the clutch must be replaced.
