Service Info

Clutch judder on PSA and FIAT vehicles with pull-type clutch

Vehicle manufacturer: Citroën, Fiat, Peugeot

Models: All models with PSA and FIAT group working with pull-type clutch

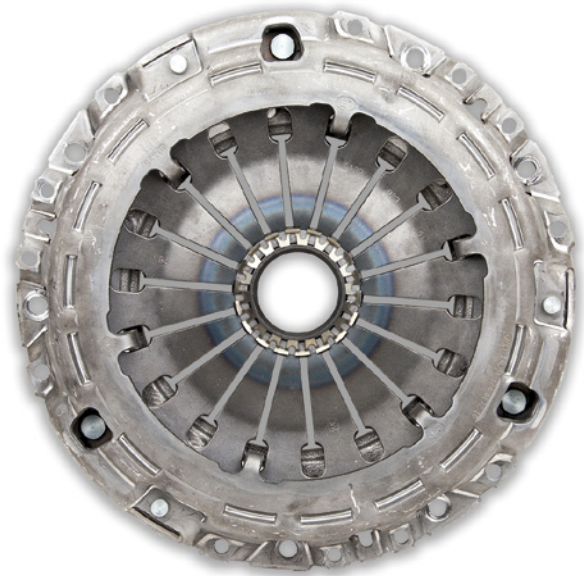
Picture 1

Some of the vehicles from PSA and FIAT groups are equipped with a clutch kit of reverse operation. In this clutch type, release fork is pulling the release bearing in order to disengage the clutch disc, instead of pushing (see pic.1).

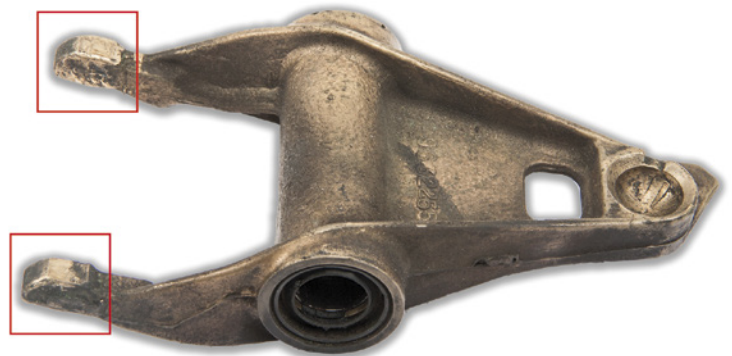
Picture 2

It is usual that, after a high number of clutch operations, this kind of release forks suffer from wear on the contact fingers. This wear may be considered as non significant.

As a consequence of the wear, the fork contact fingers create a plane surface (see pic.2), losing its spherical geometry. As a consequence, the clutch operation is not progressive, causing a sudden engagement of the clutch disc, and clutch judder when vehicle starts to move from a standstill.

Schaeffler Automotive Aftermarket recommends the replacement of the release fork on every clutch replacement.

When visual check of the release fork is performed, it is important to consider that the areas exposed to contact against the release bearing, are located on gearbox side, so they are not possible to be checked directly. These areas have to be examined using a mirror, or disassembling the release fork from the gearbox.

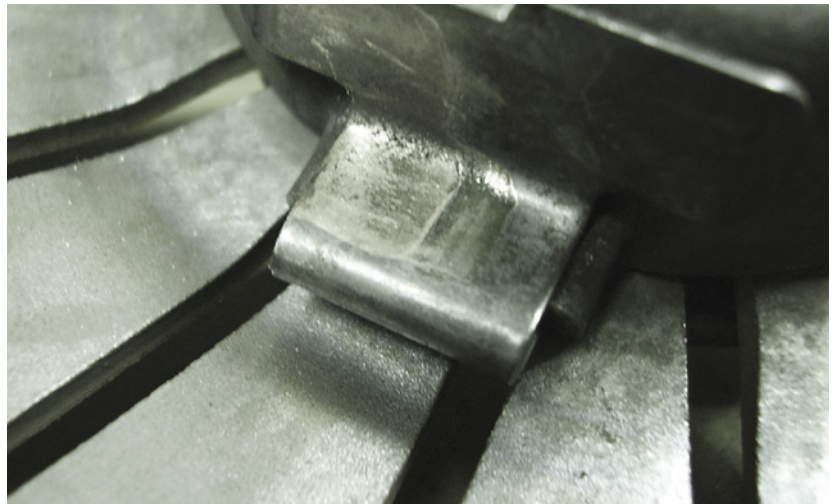
Picture 4

- Clutch jerk and judder mainly on 1st and reverse gear, caused by a non-progressive torque transmission
- Deformation or breakage of one or both release bearing lugs (see pic.4), even causing the disassembly of the release bearing from the pressure plate.

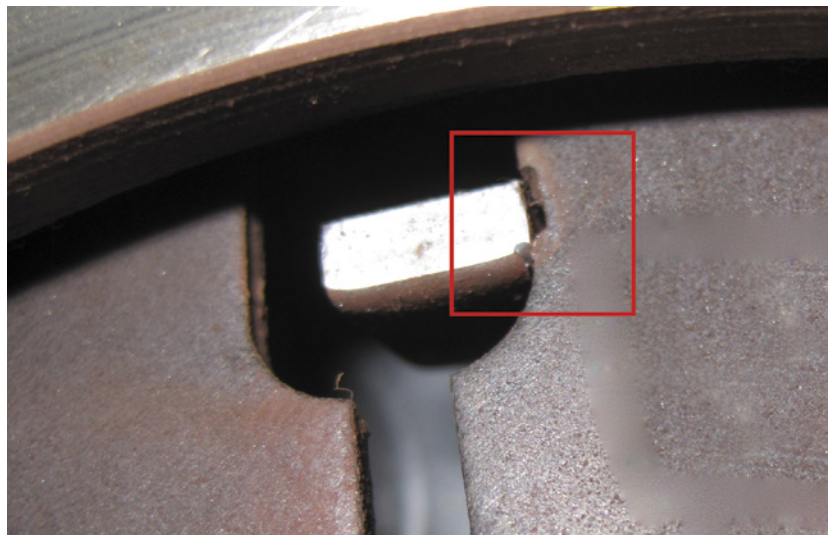
Picture 5

If diaphragm spring has suffered from rotation by excessive vibrations, and this rotation is causing contact to the pressure plate cover (pic.5), it will be necessary to proceed to clutch kit replacement. In such cases, it is strongly recommended to check the condition of the crankshaft damper.
