WATER PUMP DAMAGE PATTERNS

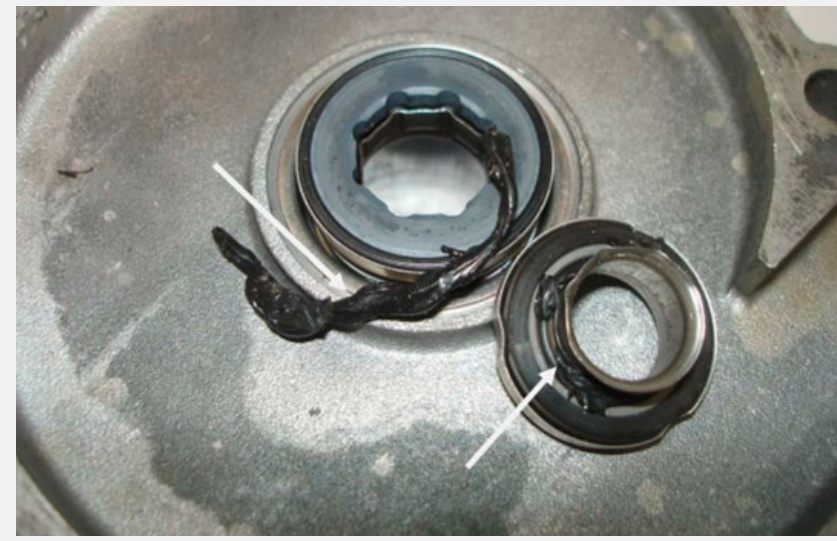
IMPROPER USE OF SEALANT

CAUSE

- Improper use of sealant is a frequent cause of water pump damage. If too much sealant is applied it may get into the cooling system and from here onto the area between the sliding ring and the stationary ring. This will then cause coolant to leak out of the water pump

SOLUTION

- After dismantling the water pump carefully remove any residual sealant from the sealing surface of the engine block
- Make sure the sealing surface is clean and that all grease particles have been removed. Evenly apply the sealant between the water pump and engine block as required to create a new seal

Note : Do not apply any sealant if the new water pump is already sealed

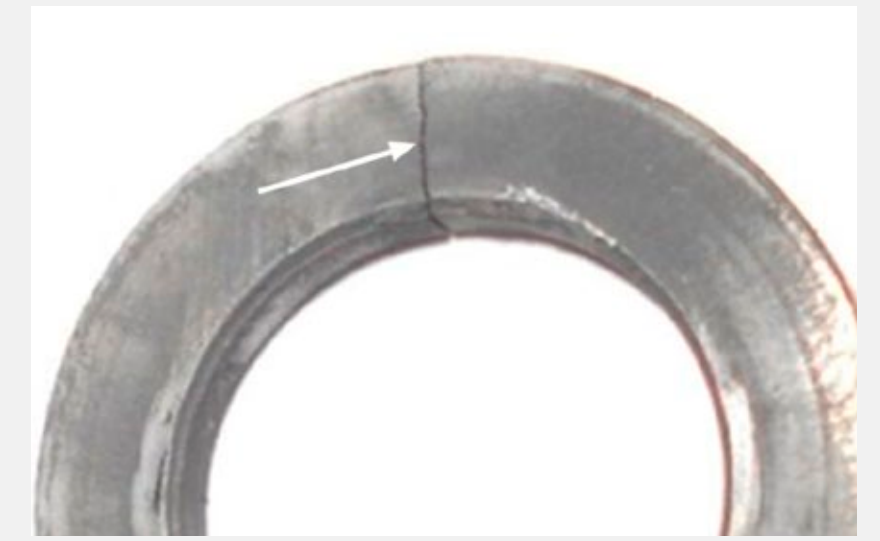
CRACKING DUE TO THERMAL SHOCK

CAUSE

- Cooling system not vented correctly or coolant level too low (which then comes in contact with gas cavities and coolant)
- Adding cold coolant into overheated engine

The damage appears as a crack across the diameter of either the seal face or the mating ring. This can also occur after a water pump replacement, if the engine is started without coolant

SOLUTION

- Vent the cooling system
- Ensure a correct coolant level
- Take proper precautions when filling radiator with coolant, especially when the engine is very hot. Allow hot engine to cool down before adding coolant. Never start the engine without coolant

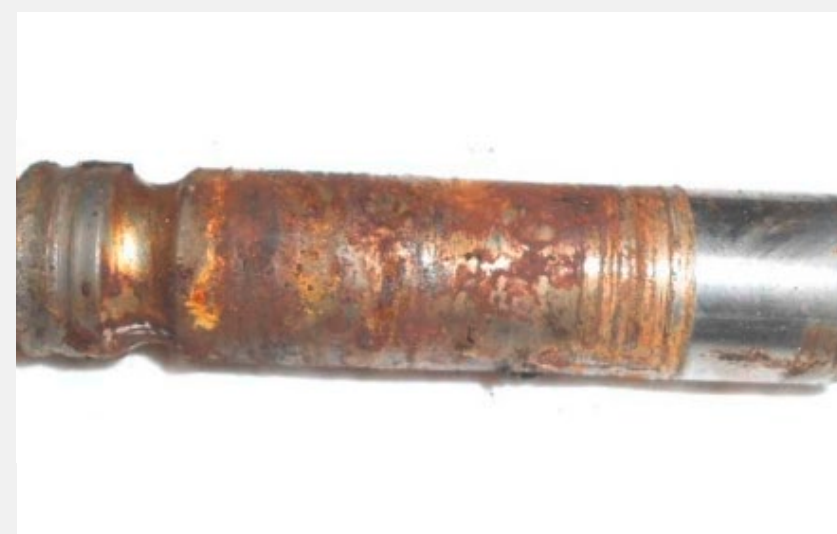
BEARING DAMAGE

CAUSE

- Leakage due to damaged mechanical seal – see "Leakage (Drainage)". A damaged mechanical seal allows coolant to penetrate the bearing, washing out the grease

SOLUTION

- See "Leakage (Drainage)"

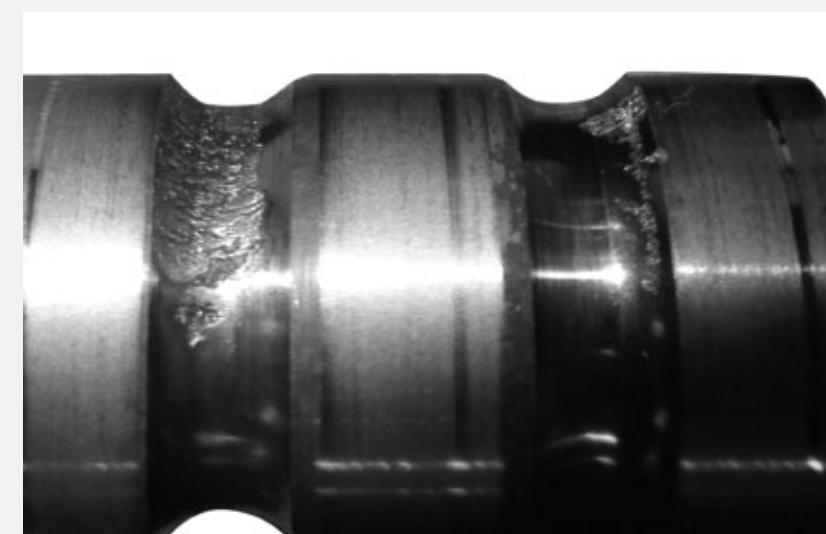
BEARING DAMAGE (EXCESSIVE LOAD)

CAUSE

- Excessive load due to incorrect belt tensioner
- Vibrations in the belt drive system
- Excessive bearing load when mounting the pump

SOLUTION

- Set the tension of the belt driving the water pump correctly; ensure that the belt, tensioner and pulleys are all aligned correctly

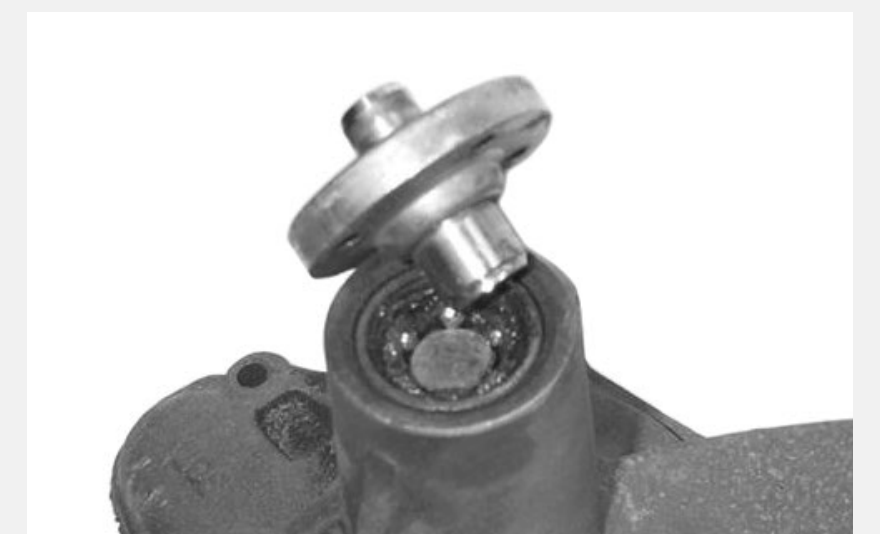
BROKEN SHAFT

CAUSE

- Excessive vibration & imbalance
- Bent, cracked, or broken fans
- Cracked or bent pulleys due to improper handling or installation
- Excessive torque on mounting bolts or improper torque sequence

SOLUTION

- Carefully check alignment of all pulleys. Also check the pulleys for straightness or fatigue. Carefully inspect fan/fan clutch assembly for a bent or damaged fan, or a worn/damaged fan clutch. Tighten the mounting bolts evenly according to the relevant vehicle manufacturer's specifications

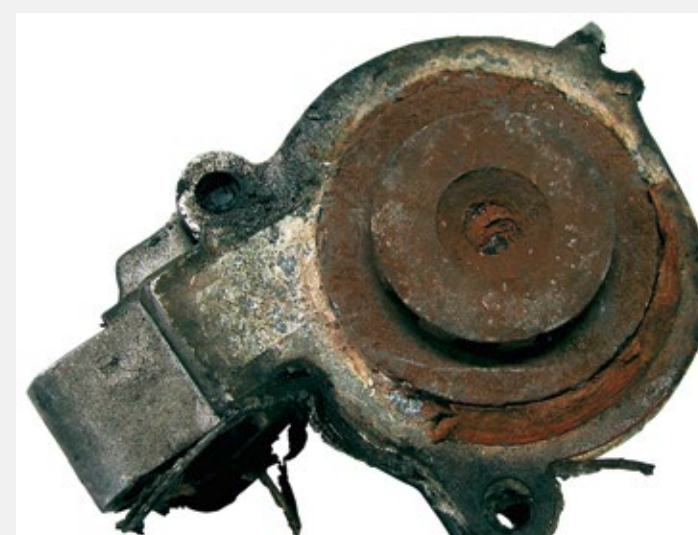
RUST AND CORROSION

CAUSE

- Wrong concentration of coolant mixture
- Inadequate coolant level

SOLUTION

- Fully flush the cooling system
- Replace with new coolant when changing the water pump
- Use correct coolant mixture
- Fill system to the correct fluid level
- Bleed cooling system

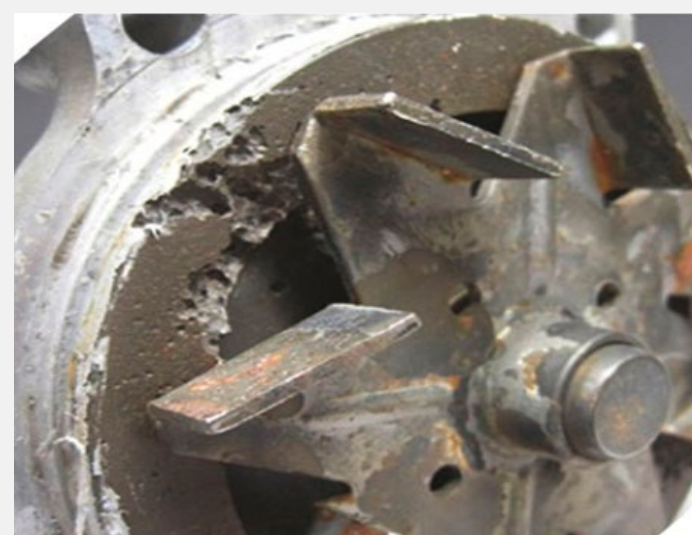
PITTING

CAUSE

- Wrong coolant
- Wrong antifreeze mixture
- Inadequate coolant level

SOLUTION

- Use manufacturer recommended antifreeze
- Repair all cooling system leaks
- Regularly test the pressure cap
- Replace faulty parts with quality products (i.e. water pump, thermostat, pressure cap)
- Avoid modifications

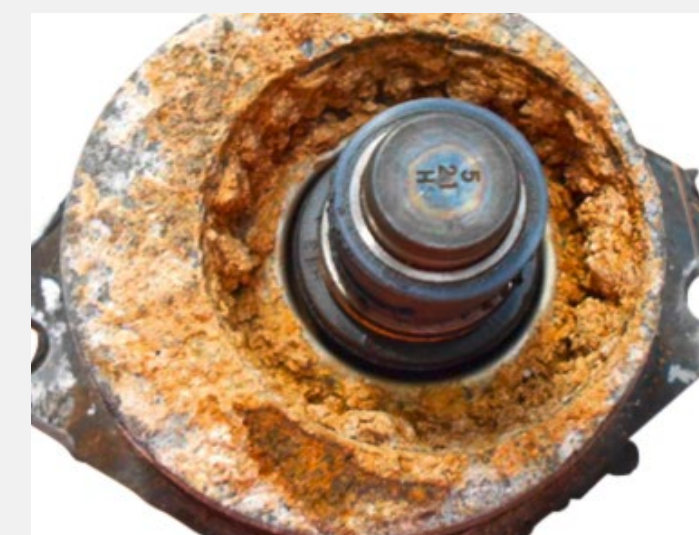
MIXED COOLANTS

CAUSE

- Using different (incompatible) coolants at the same time

SOLUTION

- Fully flush the cooling system
- Refer to the manufacturer specifications for the right coolant to use

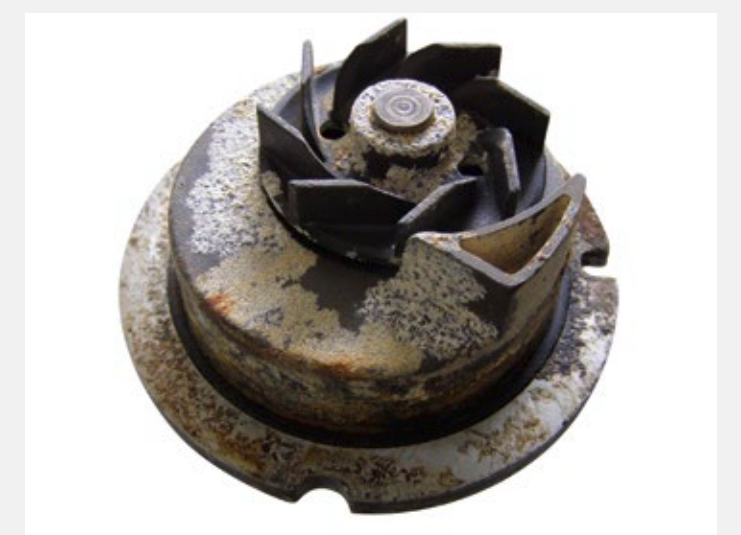
CALCIFICATION

CAUSE

- High lime content in the coolant (hard water)

SOLUTION

- Recommend to use low lime water or blend it with demineralised water

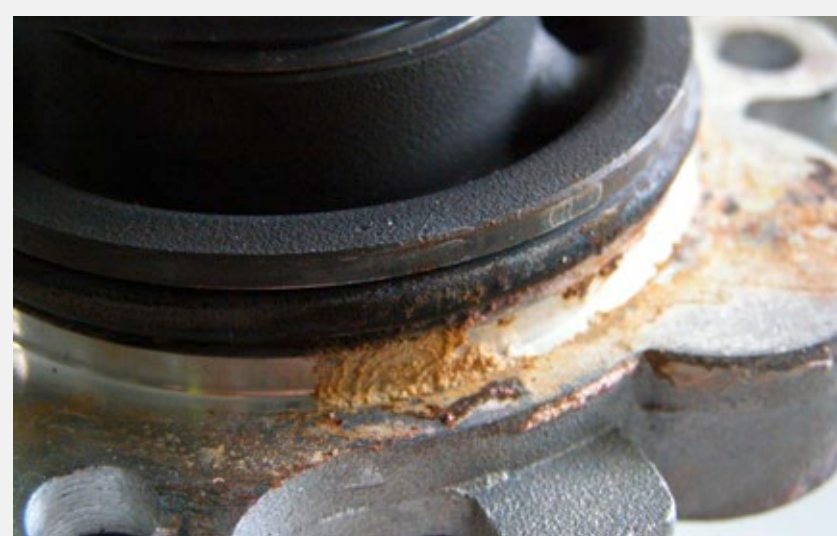
LEAKAGE FROM THE MOUNTING SURFACE

CAUSE

- Sealant applied unevenly or excessively
- Incorrect torque
- Contamination
- Mounting surface uneven

SOLUTION

- After dismantling the water pump carefully remove any residual sealant from the sealing surface of the engine block
- Do not exceed the specified tightening torques during installation
- Always use a new seal when installing the water pump

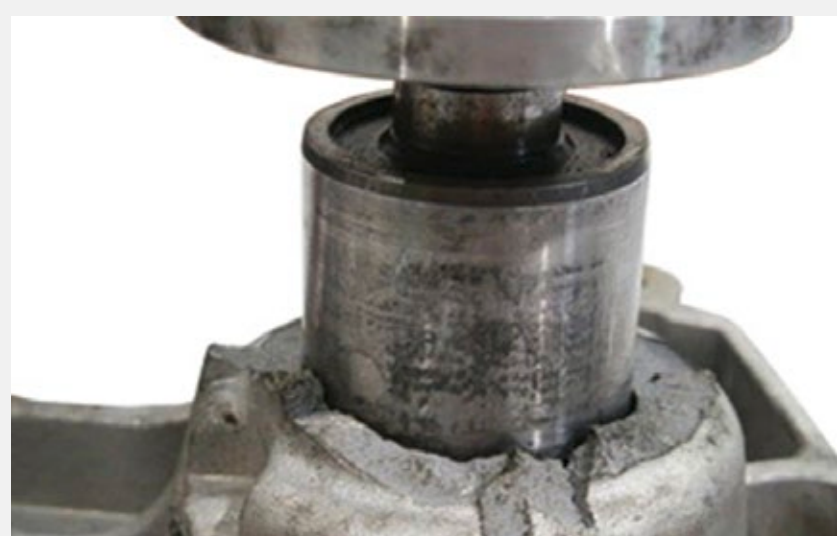
BROKEN CASTING

CAUSE

- Casting failure is normally associated with heavy vibration or imbalance which can be caused by a badly worn fan clutch or bent fan
- Excessive load when mounting the pump

SOLUTION

- Carefully inspect pulley, belt alignment and fan/fan clutch assembly, replacing any bent or worn components
- Do not use a lever or excessive force when mounting the water pump

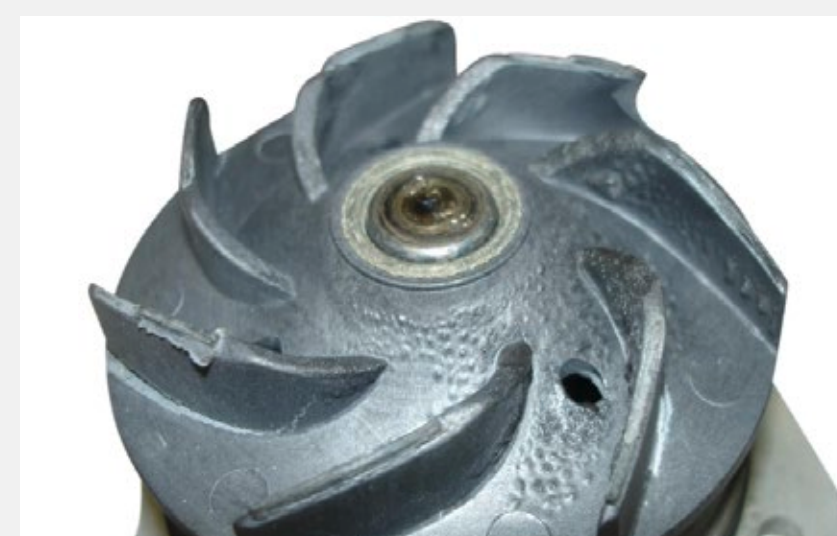
OVERHEATING

CAUSE

- Insufficient flushing of the radiator
- Damage to cylinder head/cylinder head gasket

SOLUTION

- Fully flush the radiator
- Replace coolant with manufacturer specified mixture and fluid level
- Check cylinder head/cylinder head gasket (pressure test)
